Rail Accident Investigation Branch

# Rail Accident Investigation: Interim Report

**Collision near London Waterloo station,  
15 August 2017**

Report IR2/2017  
December 2017

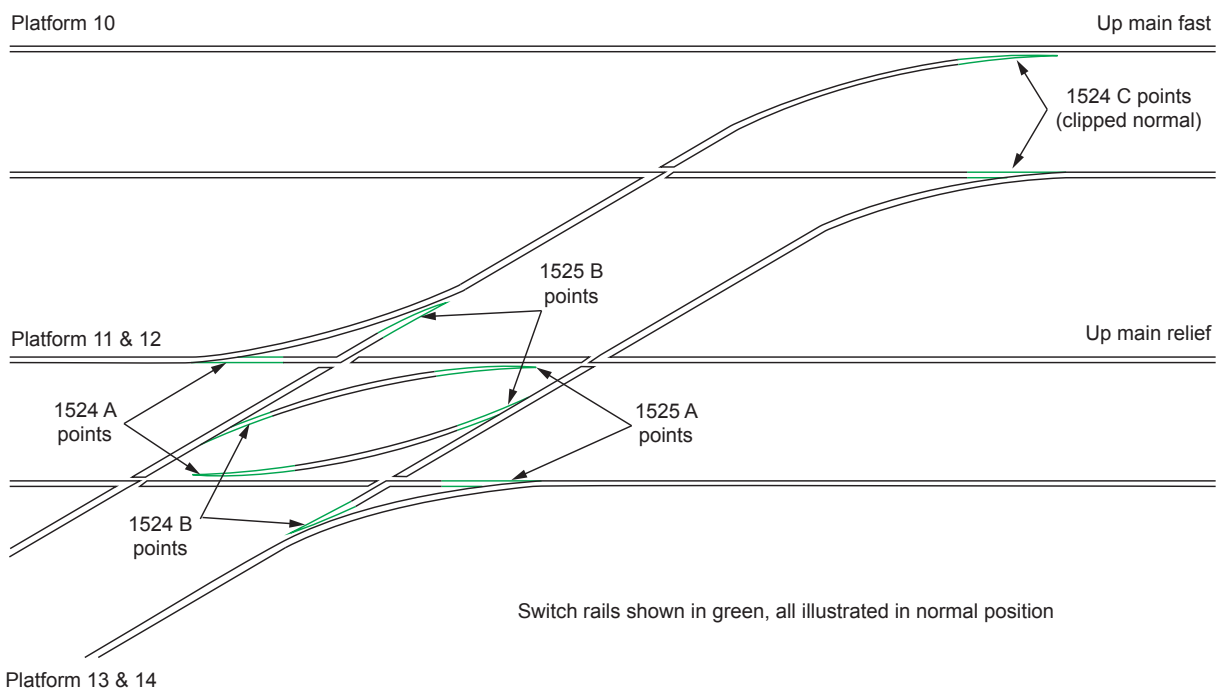
Figure 3: Detailed layout of accident location

15 Routes from platforms 11 and 12 via 1524 points would lead to the up main relief line with 1524 points *normal* and the up main fast line with 1524 points *reverse*.
